**MFR56 ULTRA LIGHT MACHINE GUN (5,56x45mm)**

### TECHNICAL SPECIFICATIONS

## TESTING

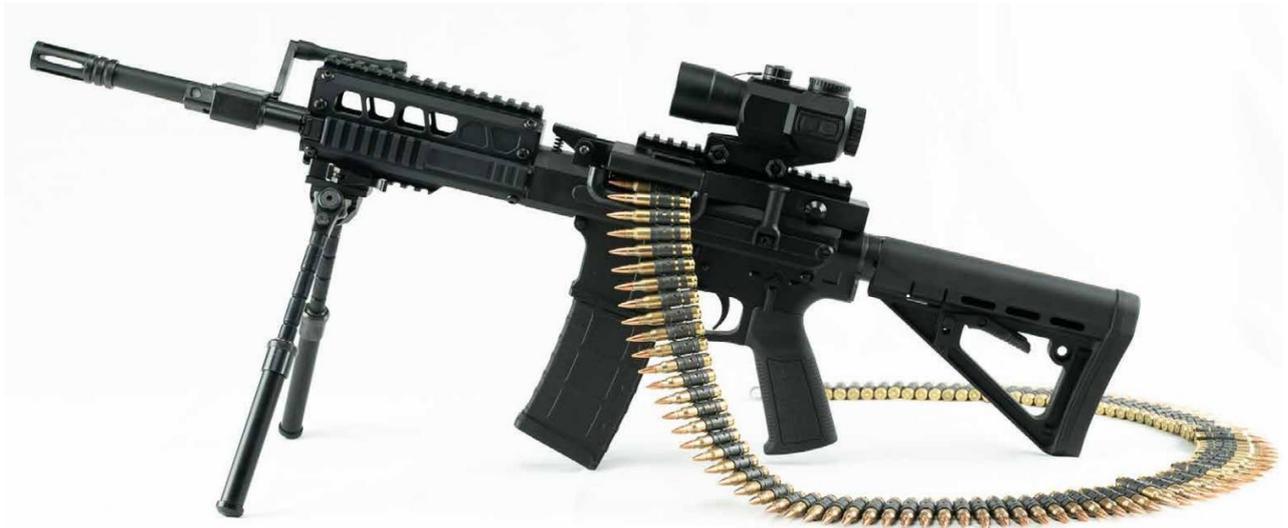
**MFR56 ULTRA LIGHT MACHINE GUN**

**5,56x45mm CALIBER**

**DUAL FEED**

**SEMI AND FULL AUTOMATIC**

**CLOSED BOLT**
